Plastic Pedestal Axial Compression Test

Test Ptotocol: ICC-ES AC300-2010, Acceptance Criteria for Access Floors

Test Sample: Tile Tech Inc. pedestals at 24-in high Source: Submitted to Laboratory by Client.

Report of Tests

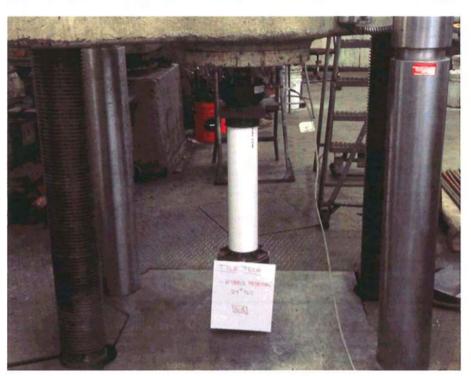
Photo No.1 General Sample Test Setup

Each tested pedestal was provided by the client ready to be tested. For this testing a spacer tab was not included. The height was adjusted to approx. 24 inches high as per client request. A Baldwin UTM with 440 Kip load capacity was used for testing. Load was applied at a rate ranged from 50 to 150 lbs. per second until failure. Photos and graphs are included in pages 2 and 3. Results are as follows:

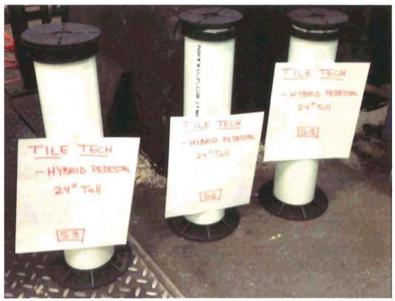
Photo No.2 Samples After Testing (failed)

Sample No.	Maximum Load, lbs.	Remarks
S3-1	10,923	Upper support failed.
S3-2	10,744	Upper support failed.
S3-3	11,757	Upper support failed.
Average:	11,141	T
